**Photodocumentation – Vibratory Finishing Area – Building 3A
Baldwin Hardware Manufacturing Corporation
Reading, Pennsylvania**

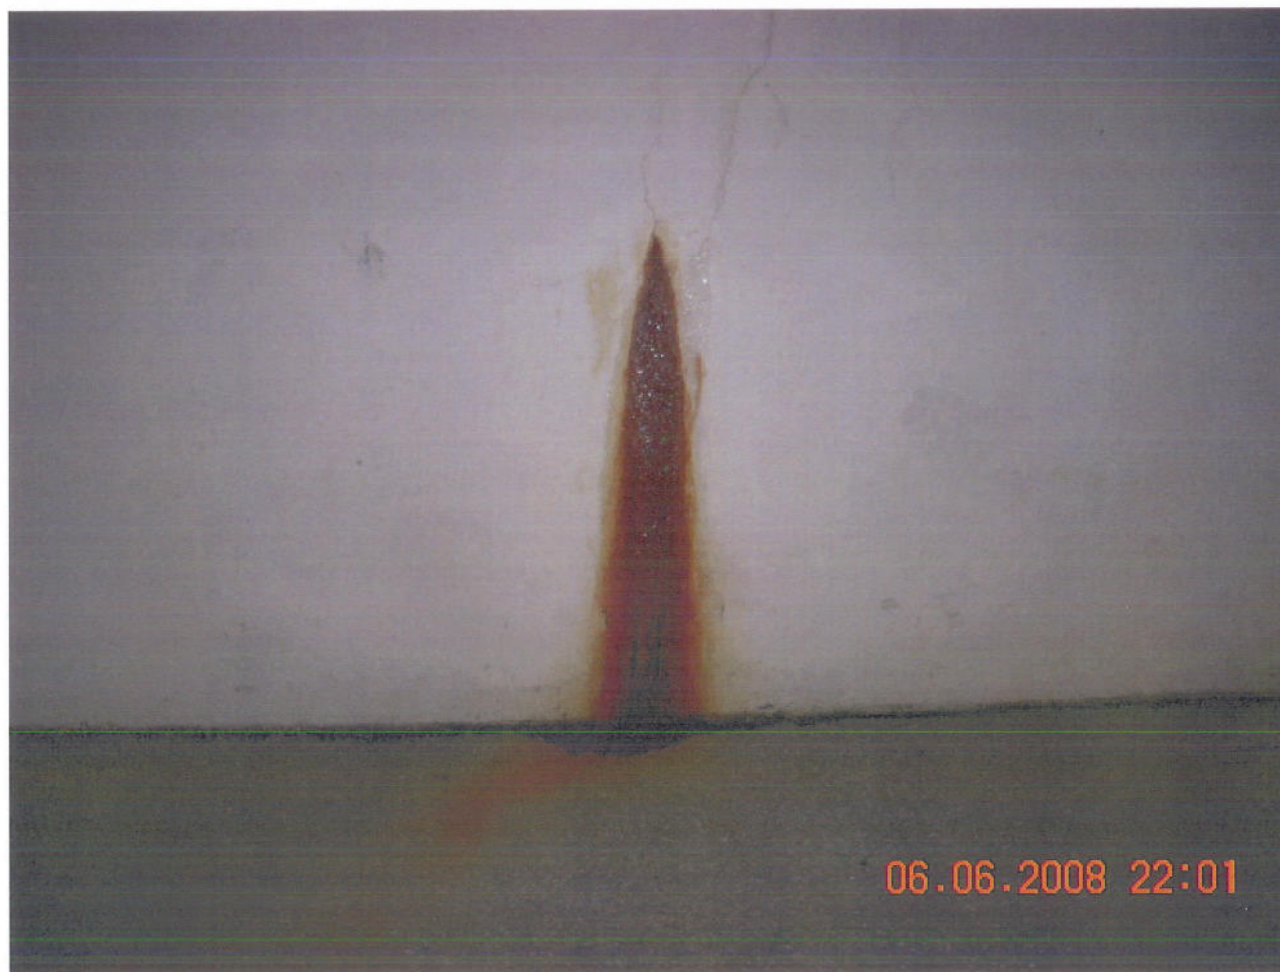
Date	Viewpoint	View Direction	Description
June 6, 2008	Driveway East of Building 3A	East	Stain on Exterior Building Wall

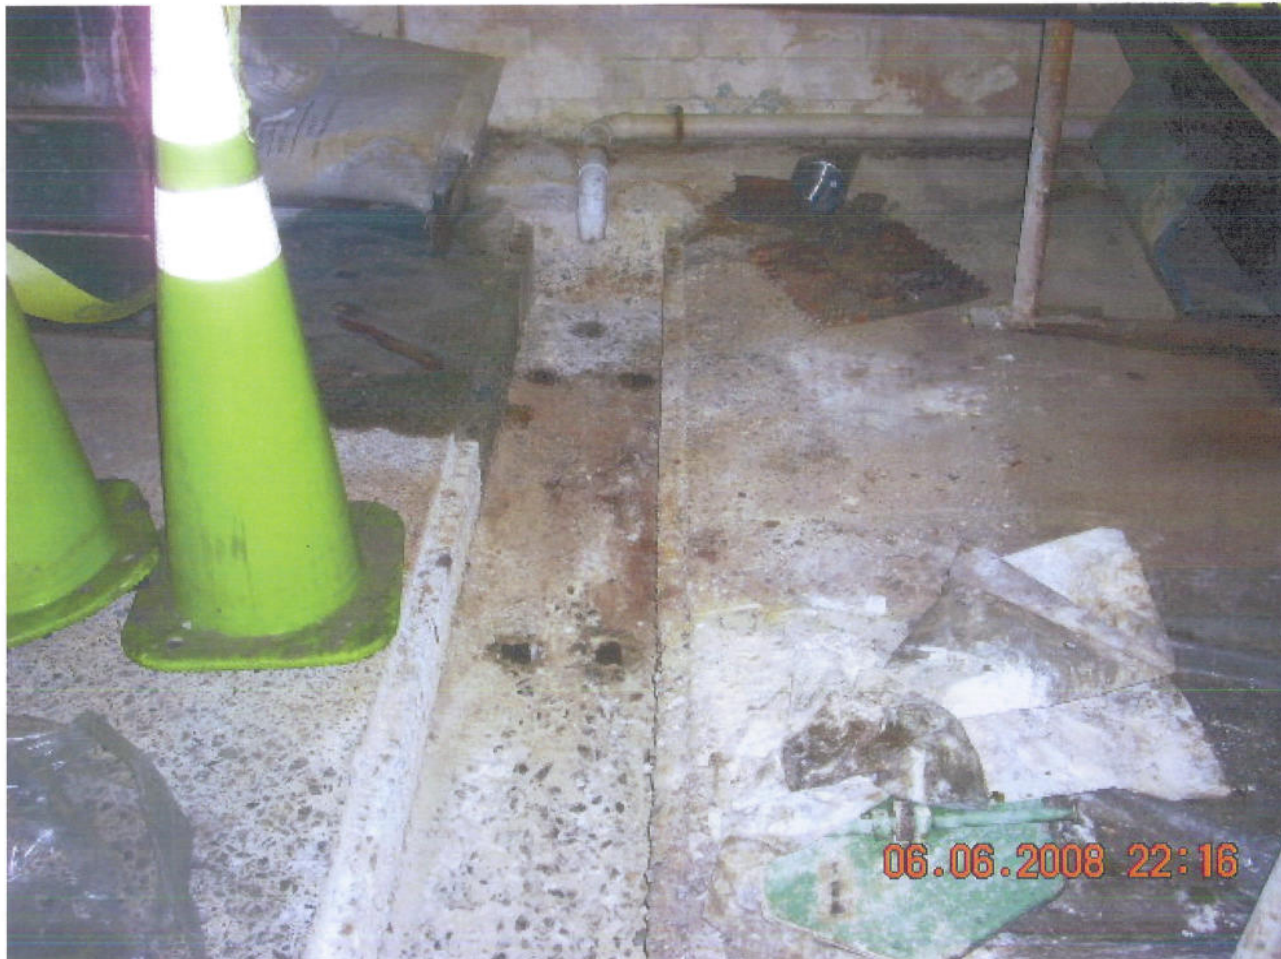
Date	Viewpoint	View Direction	Description
June 6, 2008	Along Concrete Trench Within Building 3A	East	Concrete Trench – Note Pairs of Stakes Within Trench

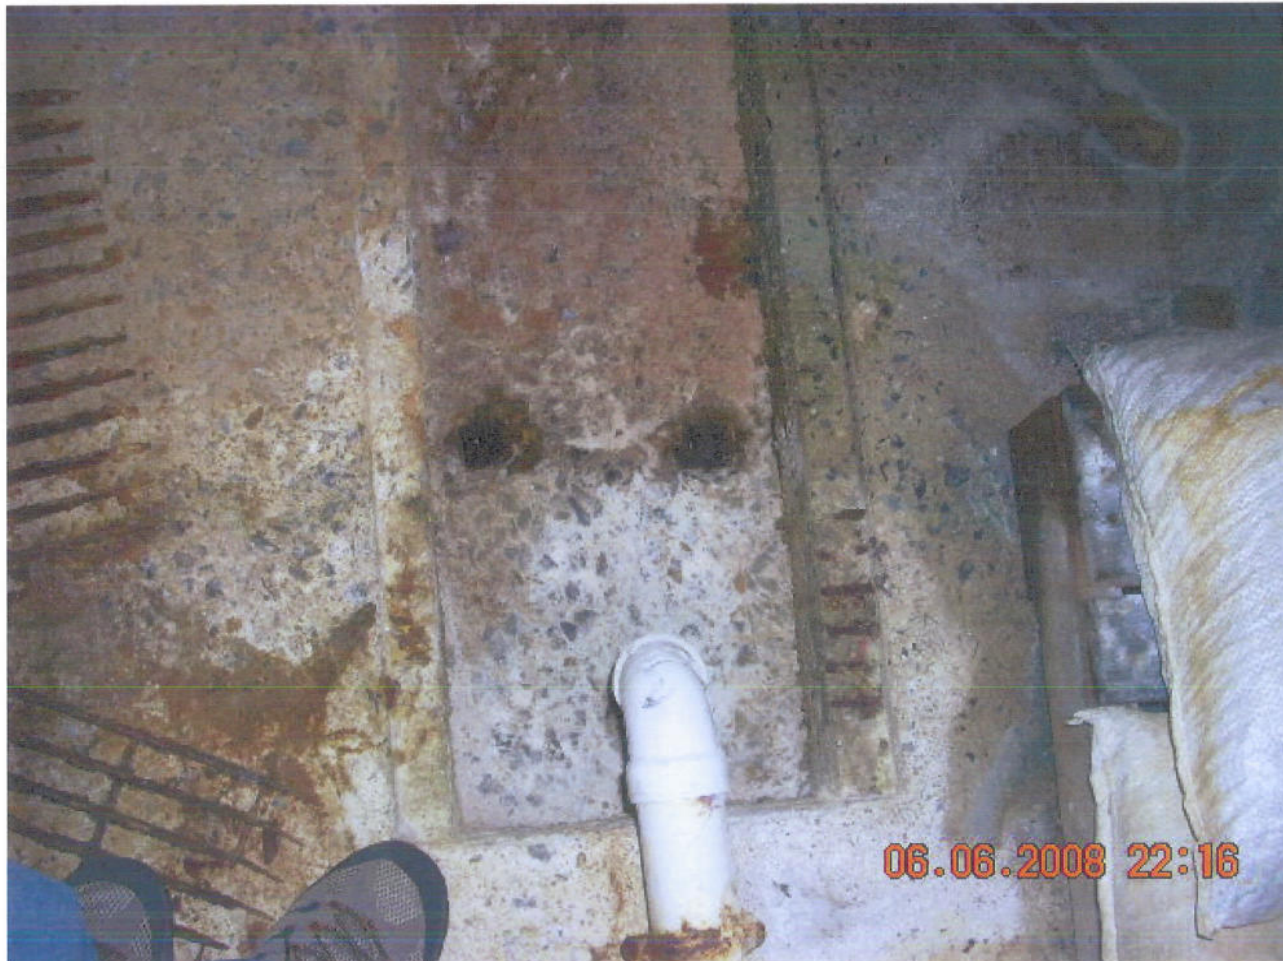
Date	Viewpoint	View Direction	Description
June 6, 2008	At East End of Concrete Trench Within Building 3A	-	Concrete Trench – Note Pairs of Stakes Within Trench

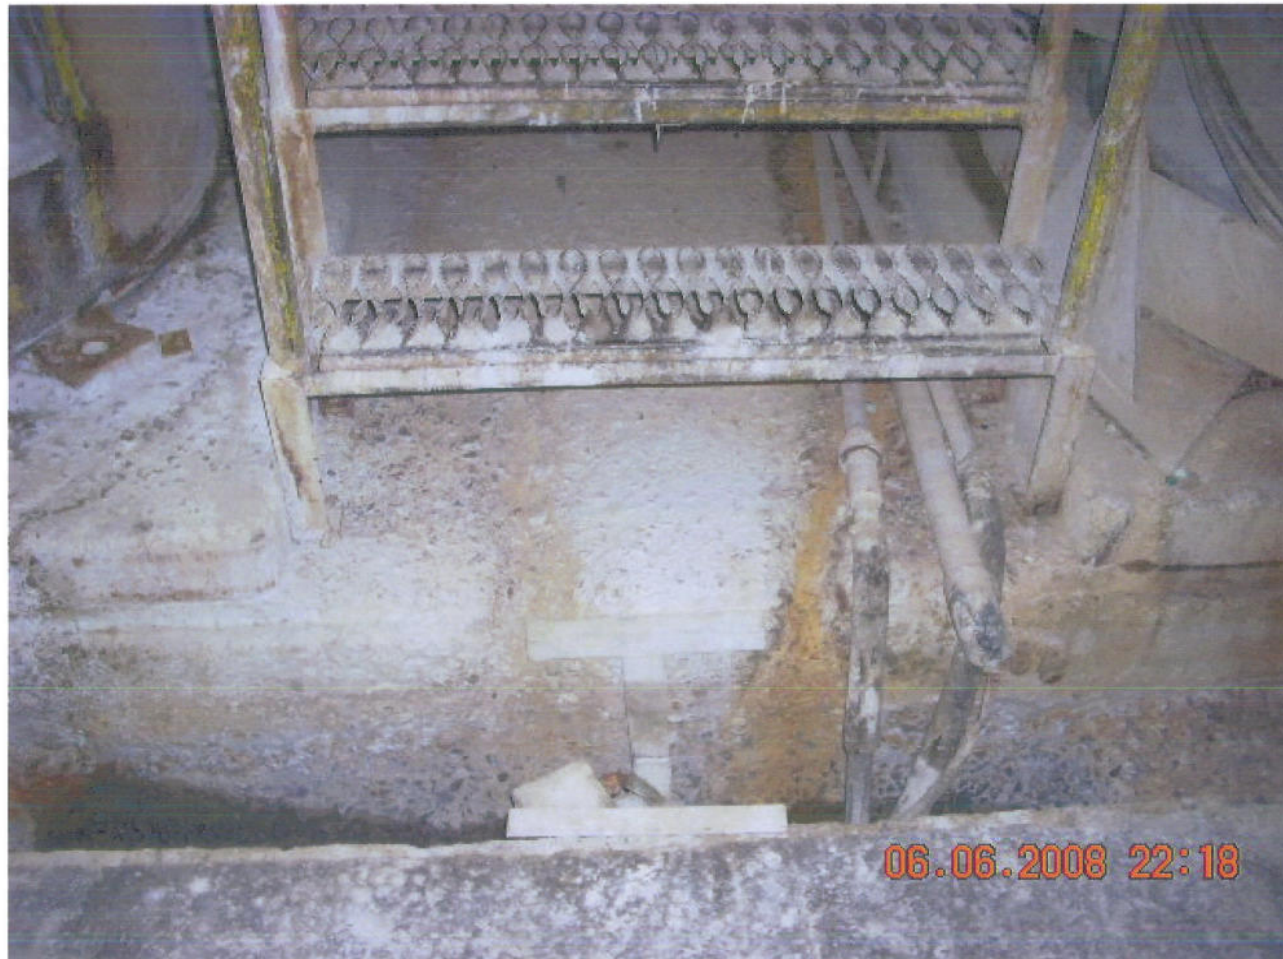
Date	Viewpoint	View Direction	Description
June 6, 2008	Building 3A	North	Mid-Section of Concrete Trench Showing Location of the Sump

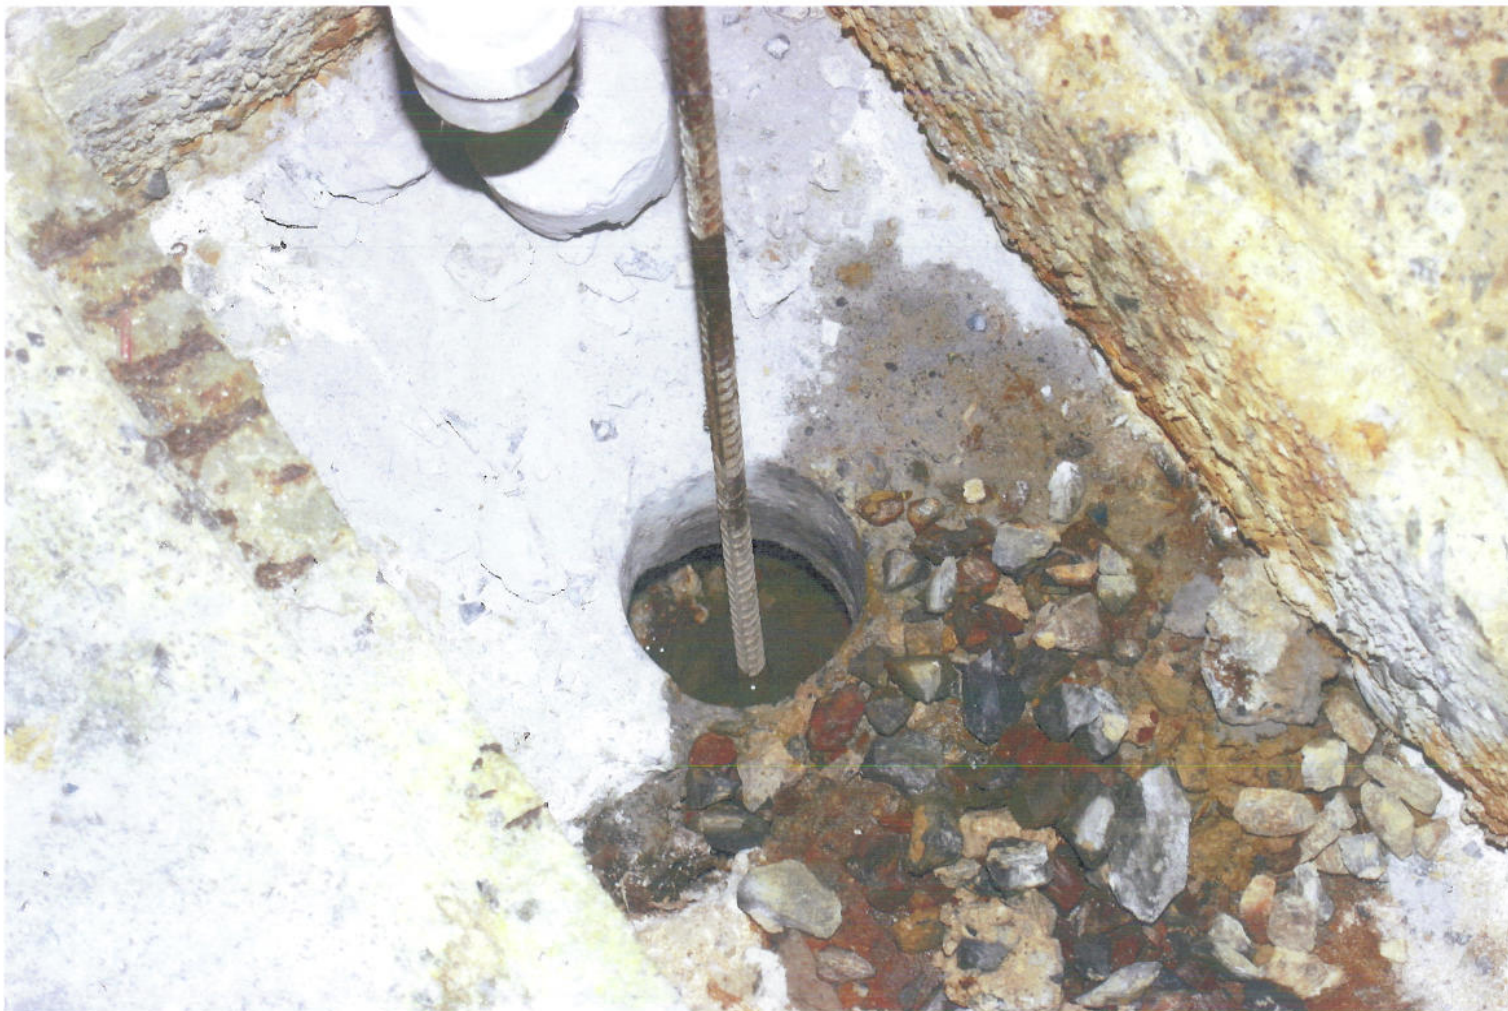
Date	Viewpoint	View Direction	Description
June 11, 2008	Building 3A	--	Core Through the East End of the Concrete Trench

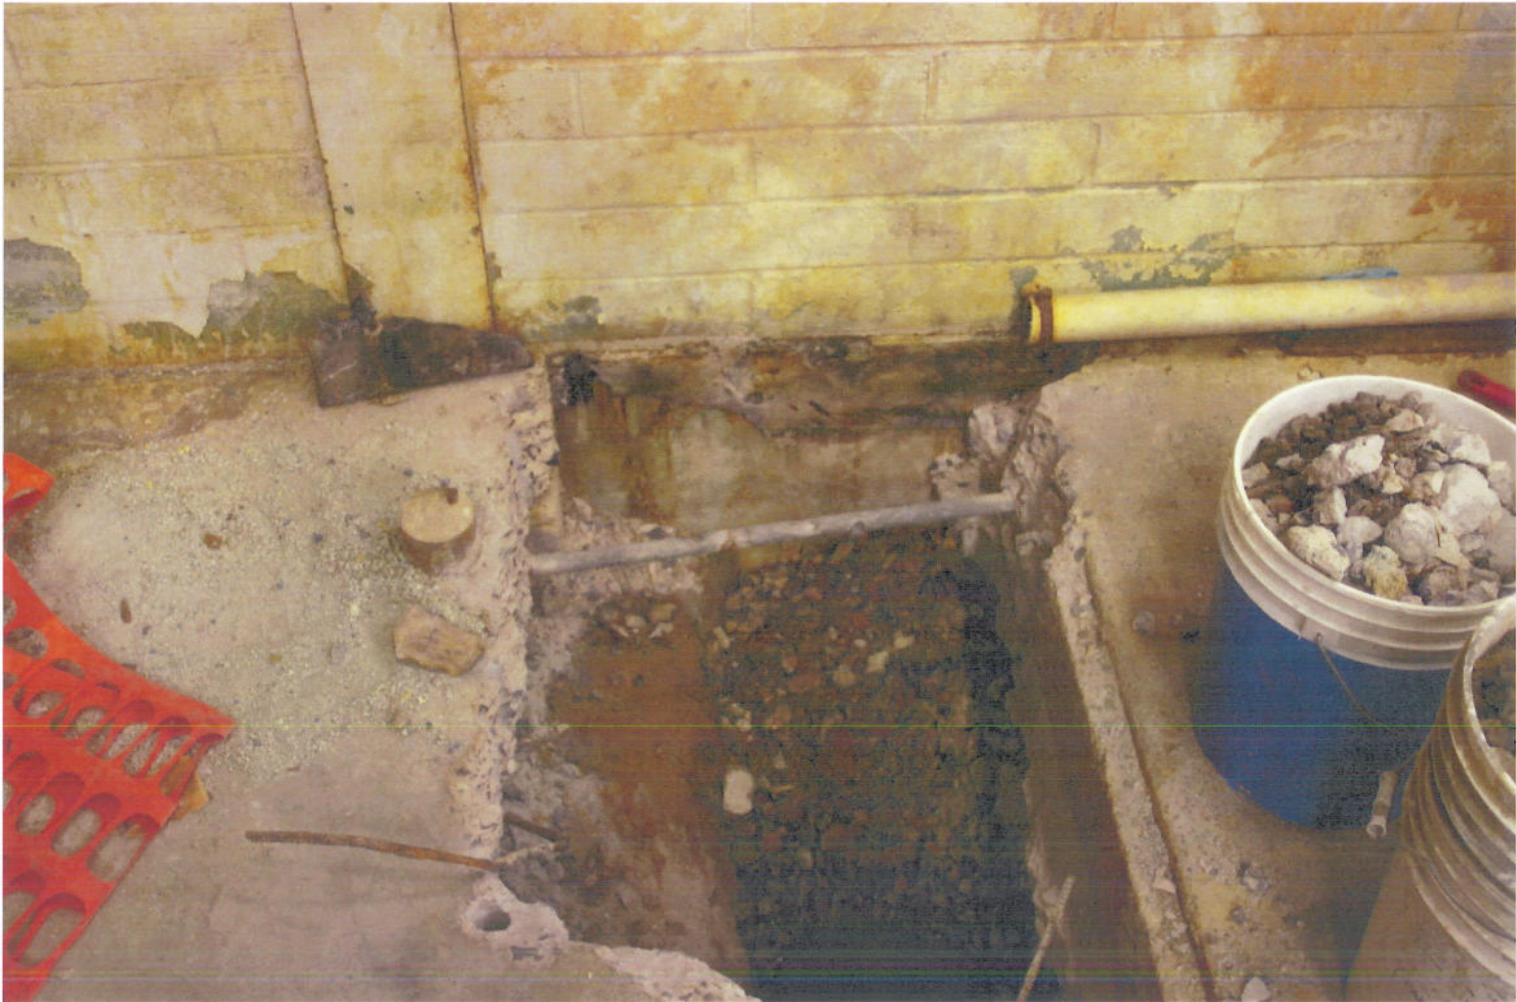
Date	Viewpoint	View Direction	Description
June 12, 2008	Building 3A	West	Exposed Foundation Wall at the West End of the Concrete Trench

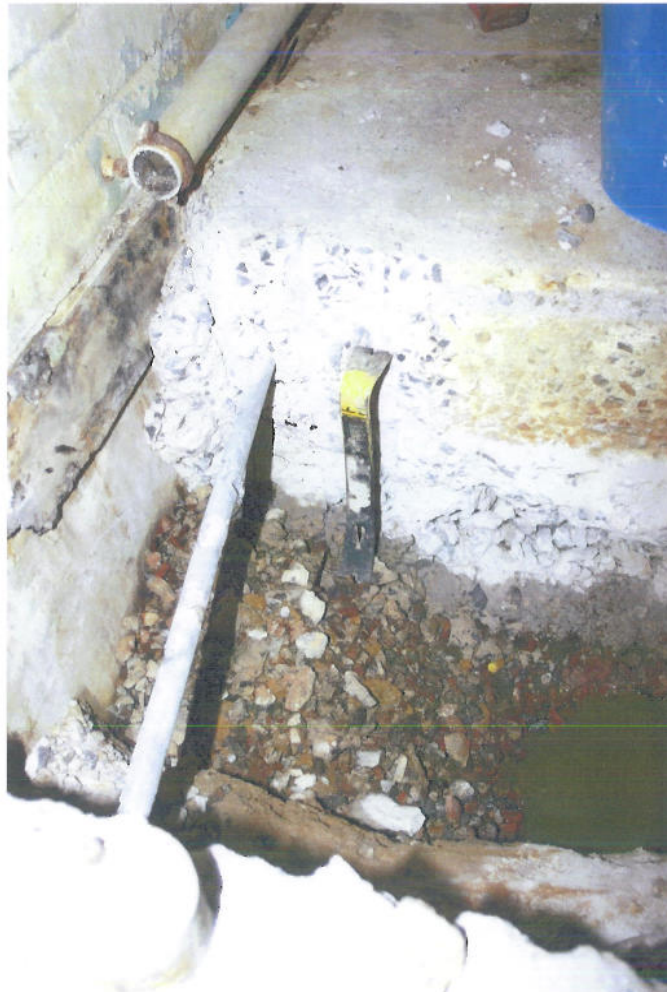
Description
West End of the Concrete Trench Showing the
Thickness of the Concrete Slab and Sub-Base Material

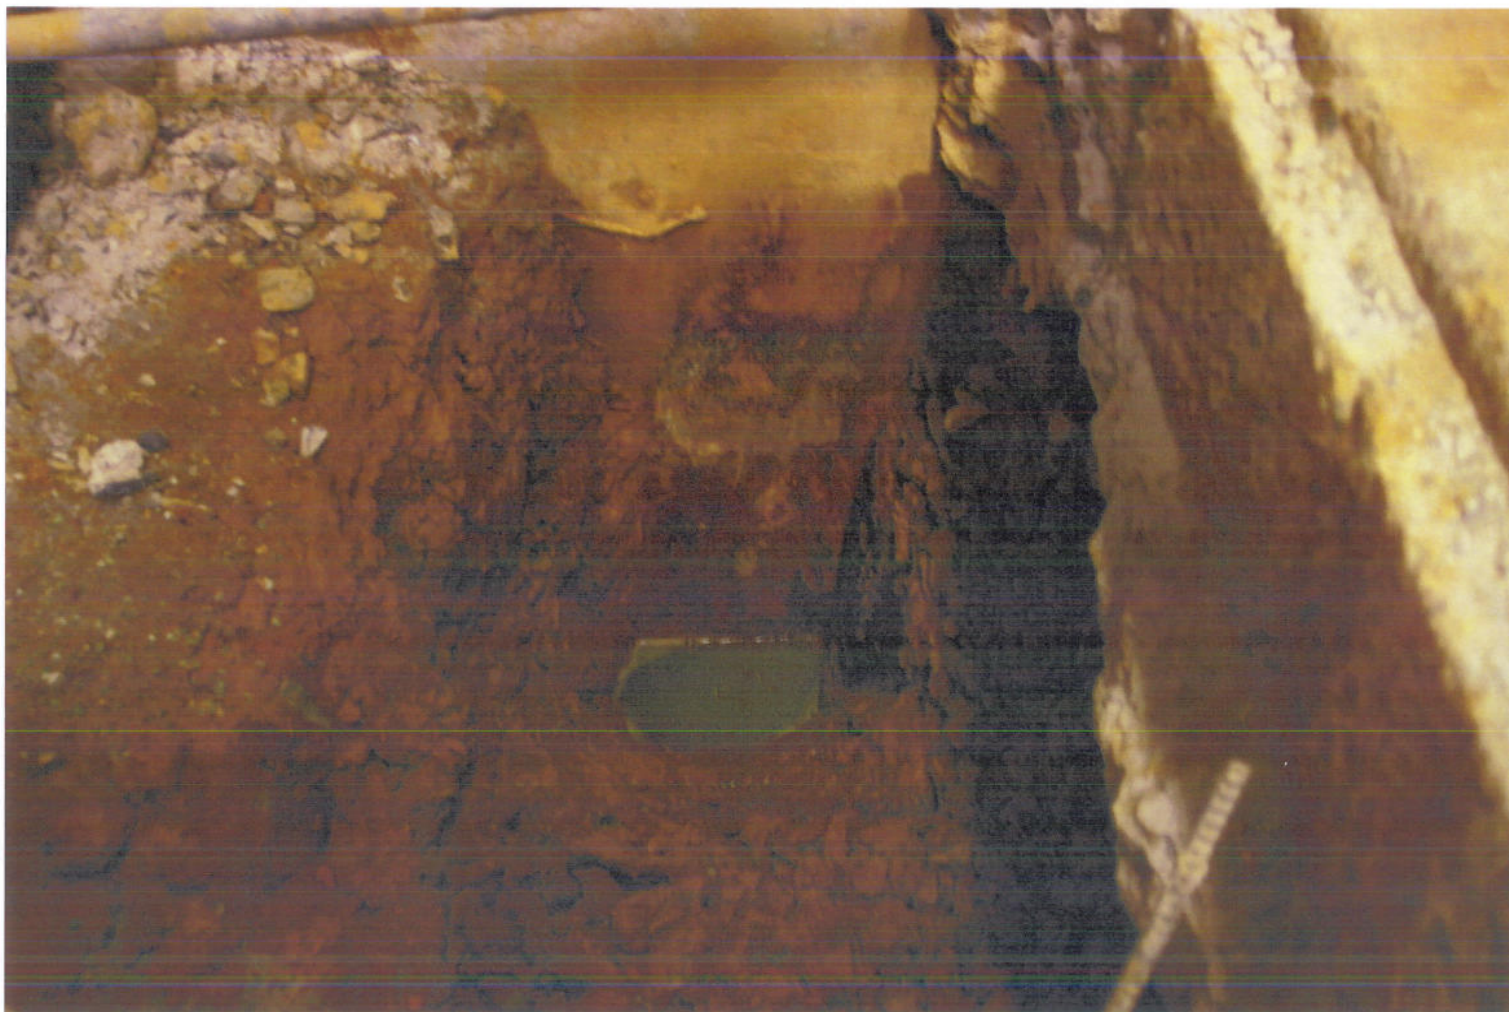
Date	Viewpoint	View Direction	Description
June 12, 2008	Building 3A	West	Subsurface Soil Beneath Concrete Trench/Slab and Sub-Base Material
